COOKWARE	Date: Datum:	15.03.2022
Applicant / Client : Antragsteller / Kunde:	ILAG intern		
Item: Artikel:	26cm frying pan	Article No.: Artikel Nr.:	-
Manufacturer: Hersteller:	Kolimax		
Application: Applikation:	Spray		
Label / Coating: Beschichtungssystem:	DURIT Granitec HL	Coating Supplier: Lackhersteller:	ILAG
Code No. Coating: Produktnr. Beschichtung:	LB30746 LB31937 LB31734 LB31735 LB31563	Substrat: Untergrund:	Stainless steel
Delivery condition: Zustand bei Anlieferung:	Good	Date of receipt: Eingangsdatum:	28.02.2022
Testing LAB: Prüflabor:	Ilag AG (Wangen), Switzerland		
Test results: Prüfergebnisse:	The quality of the tested pans is overall good and meets the expectations of the coating material.		
Others / Remarks: Diverses / Bemerkung:			
Tested by / durchgeführt von:		Checked by / überprüft von:

1. Basic tests

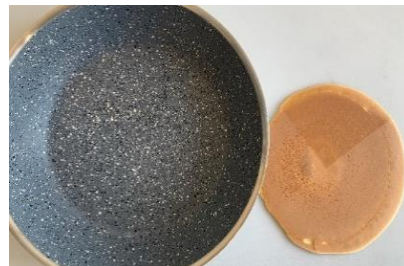
Result:	Abrasion	2.00 pts	good
---------	----------	----------	-------------

Non-stick	Pancake	excellent
-----------	---------	------------------

Non-stick Milk

good

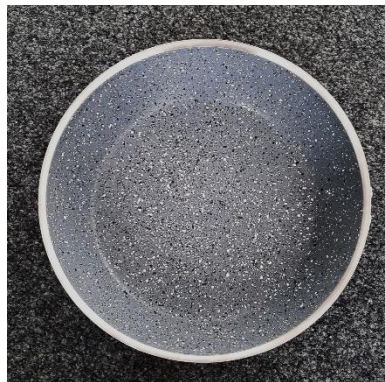
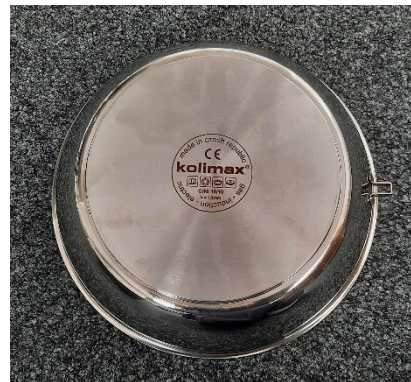
4. Sample photos

Result: many big cracks
