COOKWARE	Date: Datum:	15.03.2022
Applicant / Client : Antragsteller / Kunde:	ILAG intern		
Item: Artikel:	26cm frying pan	Article No.: Artikel Nr.:	-
Manufacturer: Hersteller:	Kolimax		
Application: Applikation:	Spray		
Label / Coating: Beschichtungssystem:	DURIT Professional S	Coating Supplier: Lackhersteller:	ILAG
Code No. Coating: Produktnr. Beschichtung:	LB31775 LB31773 LB31774	Substrat: Untergrund:	Stainless steel
Delivery condition: Zustand bei Anlieferung:	Good	Date of receipt: Eingangsdatum:	28.02.2022
Testing LAB: Prüflabor:	ilag AG (Wangen), Switzerland		
Test results: Prüfergebnisse:	The quality of the tested pans is overall good and meets the expectations of the coating material.		
Others / Remarks: Diverses / Bemerkung:			
Tested by / durchgeführt von:	Checked by / überprüft von:

1. Basic tests

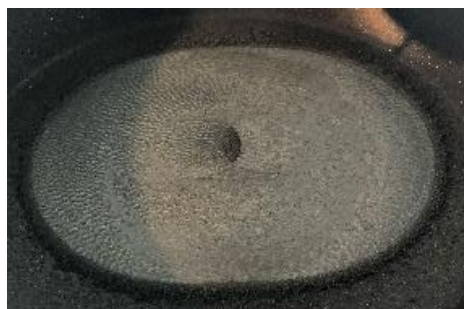
Result: After 3 hours **good**

Remarks: There might be a small first metal contact after 2-3 hours but it is not clear.

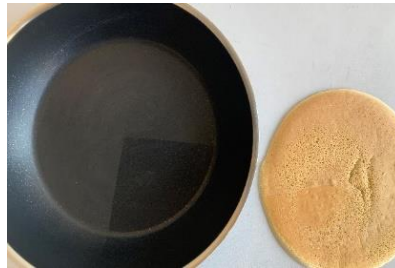
Result: Abrasion 2.00 pts **good**

Non-stick Pancake **excellent**

Non-stick Milk **very good**
